Conservation Restriction  
**Baseline Documentation Report**

**Restriction Name:** King Oak Hill Park

**Date of Report:** July 10, 2018

**Property Location:** 790 Commercial St., Weymouth

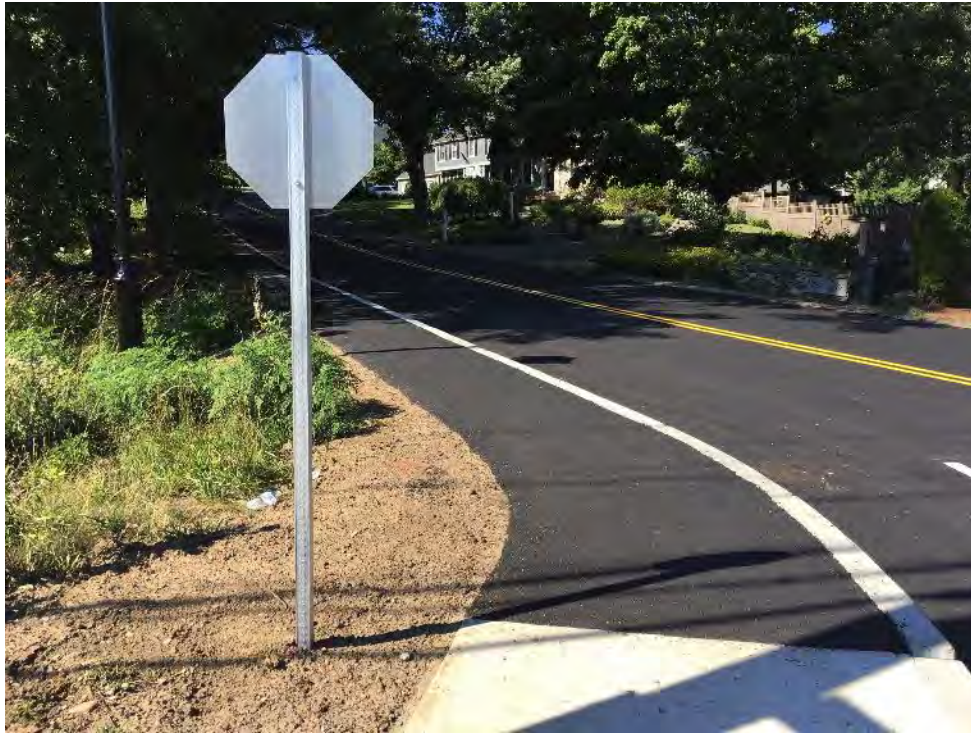
Date	Waypoint #	Photo #	JPEG File Number	Location Description	Cardinal Direction	Description of Photo Subject
7/9/18	1	1	shpimg_981.jpg	Entrance; outside CR; CR in front	N	Entrance and stone wall; boundaries with abutters were redefined from an updated survey (See Monitoring Map)

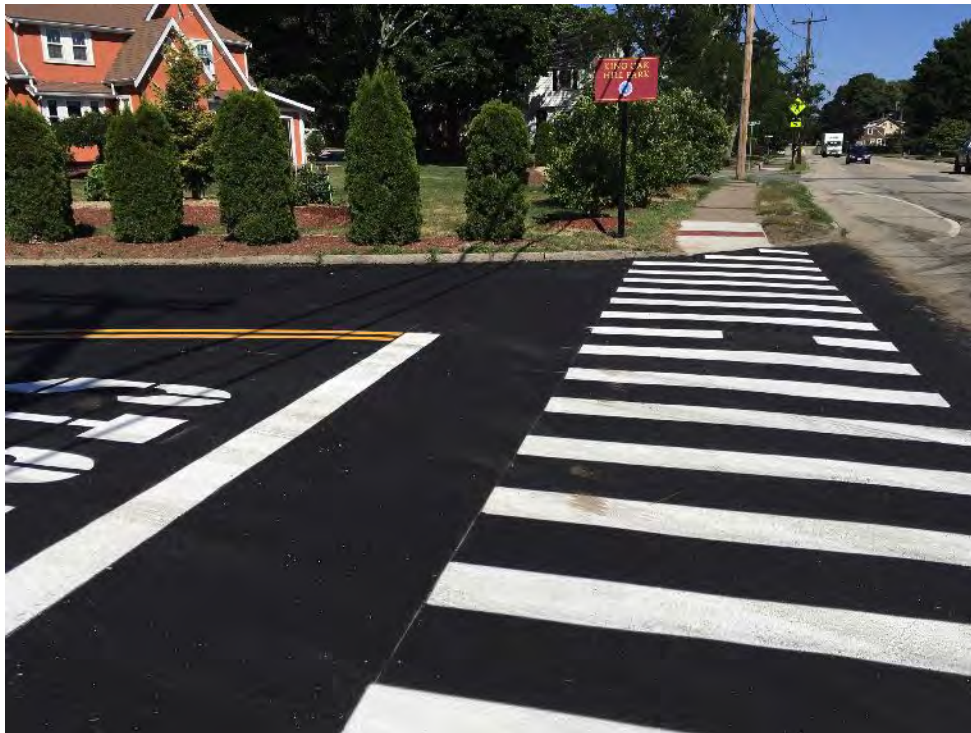
Date	Waypoint #	Photo #	JPEG File Number	Location Description	Cardinal Direction	Description of Photo Subject
7/9/18	1	2	shpimg_982.jpg	Entrance; outside CR; CR to left	E	Entrance and stone wall; boundaries with abutters were redefined from an updated survey (See Monitoring Map)

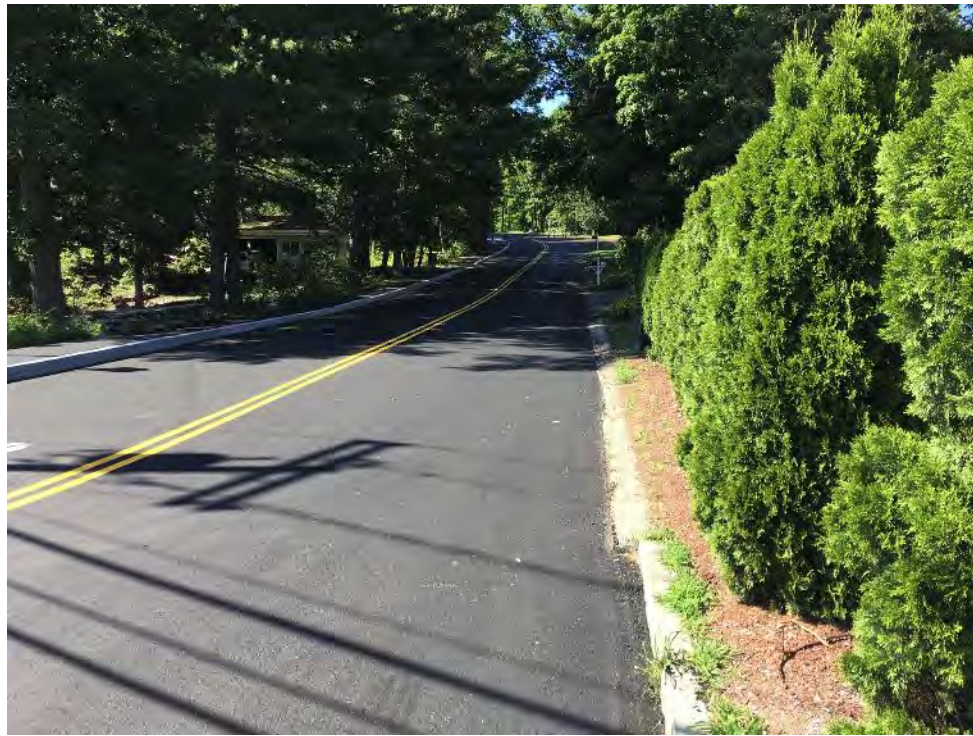
Date	Waypoint #	Photo #	JPEG File Number	Location Description	Cardinal Direction	Description of Photo Subject
7/9/18	2	3	shpimg_983.jpg	Entrance East; outside CR; CR in front	N	Emery Lane and gated entrance; survey's concrete bound drill hole (CBHD) covered and not found

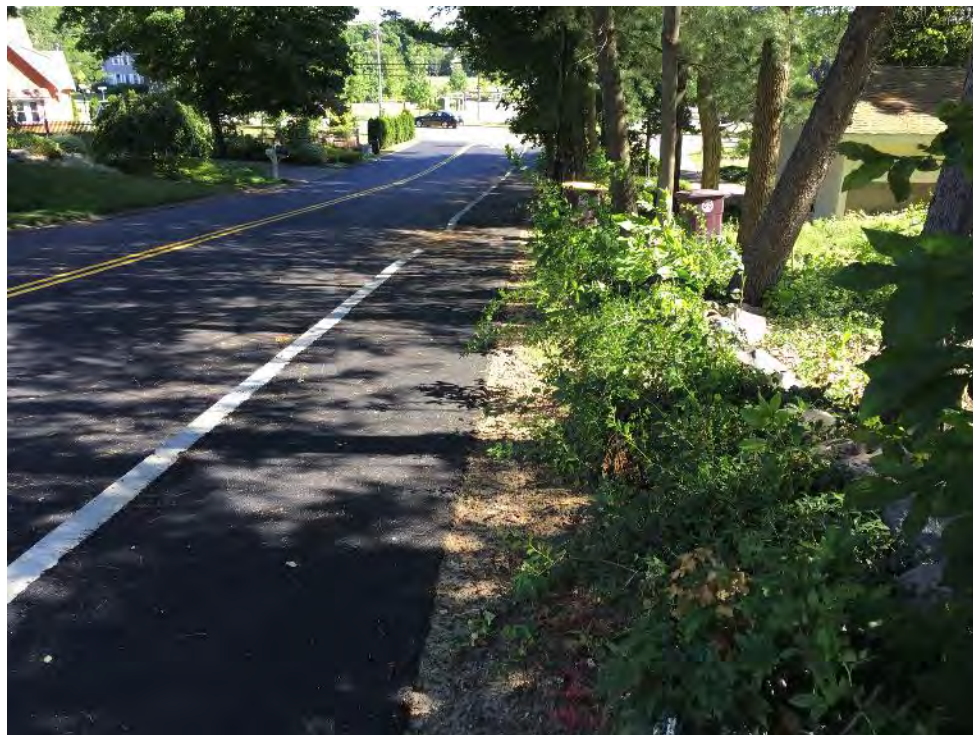
Date	Waypoint #	Photo #	JPEG File Number	Location Description	Cardinal Direction	Description of Photo Subject
7/9/18	3	4	shpimg_984.jpg	Emery Lane; inside CR; CR to left	S	Stone wall on right marks property boundary (Not on survey)

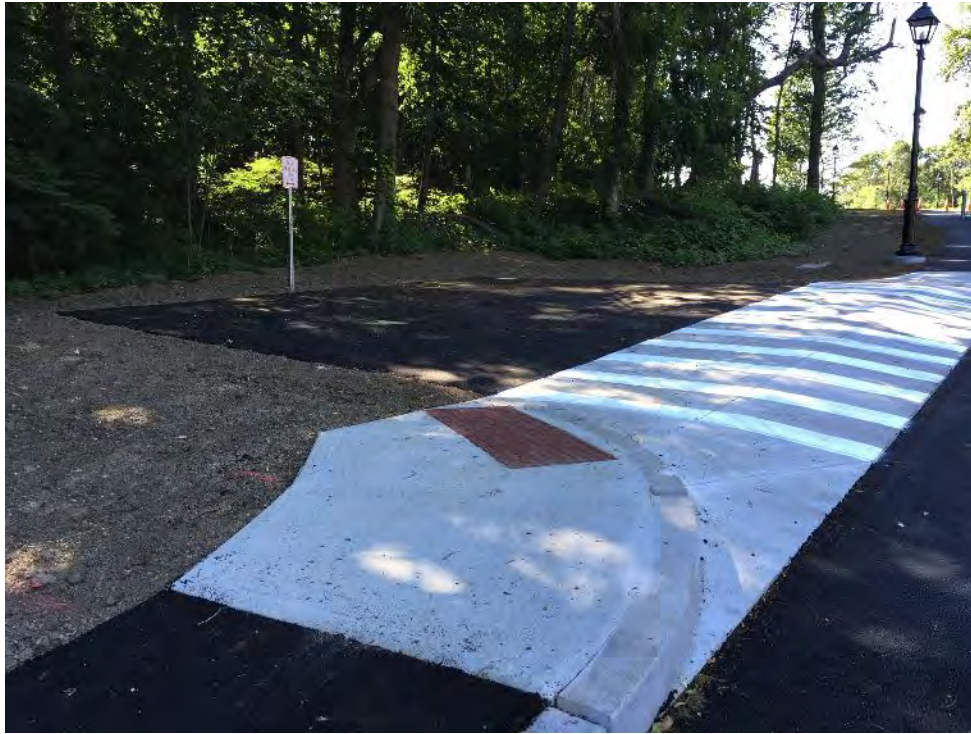
Date	Waypoint #	Photo #	JPEG File Number	Location Description	Cardinal Direction	Description of Photo Subject
7/9/18	4	5	shpimg_985.jpg	Emery Lane; inside CR; CR in front	NW	New hammerhead turnaround

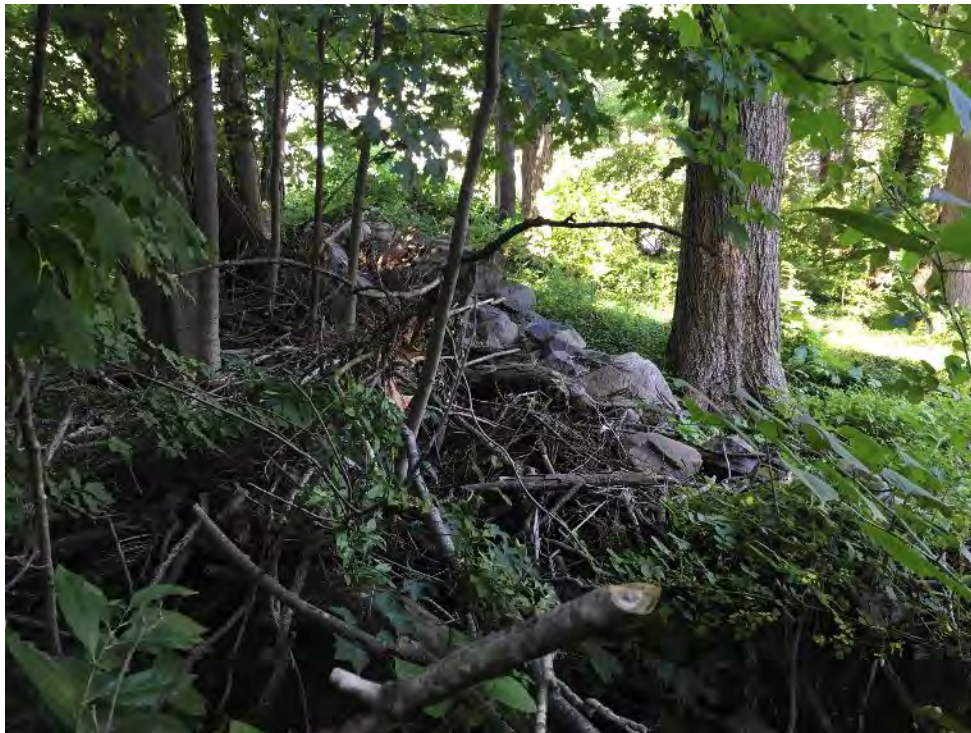
Date	Waypoint #	Photo #	JPEG File Number	Location Description	Cardinal Direction	Description of Photo Subject
7/9/18	5	6	shpimg_986.jpg	S dog leg; inside CR	W	Stone wall on boundary line

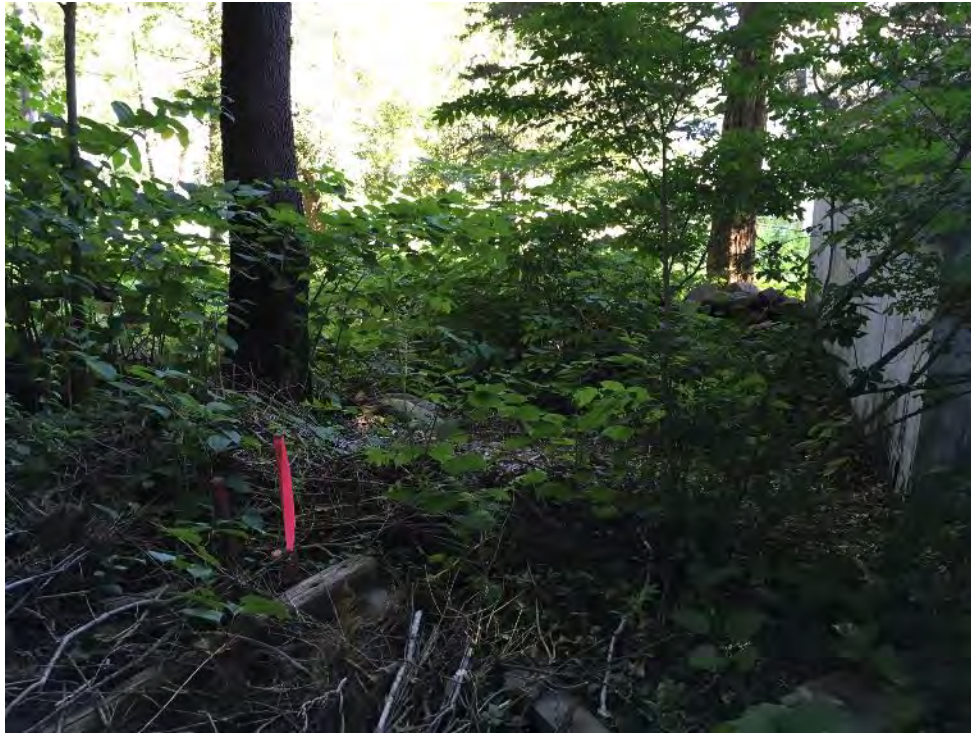
Date	Waypoint #	Photo #	JPEG File Number	Location Description	Cardinal Direction	Description of Photo Subject
7/9/18	6	7	shpimg_987.jpg	SW corner; inside CR; CR all around	SE	Flagged stakes and iron pin (ip) (On survey)

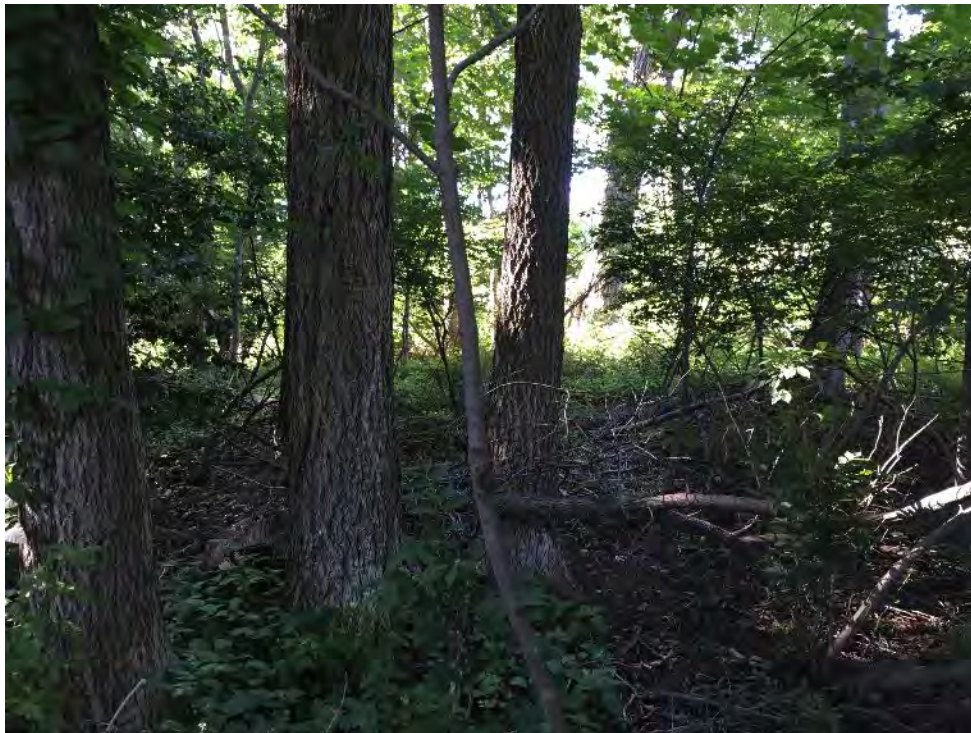
Date	Waypoint #	Photo #	JPEG File Number	Location Description	Cardinal Direction	Description of Photo Subject
7/9/18	6	8	shpimg_988.jpg	SW corner; inside CR; CR to right	N	Boundary

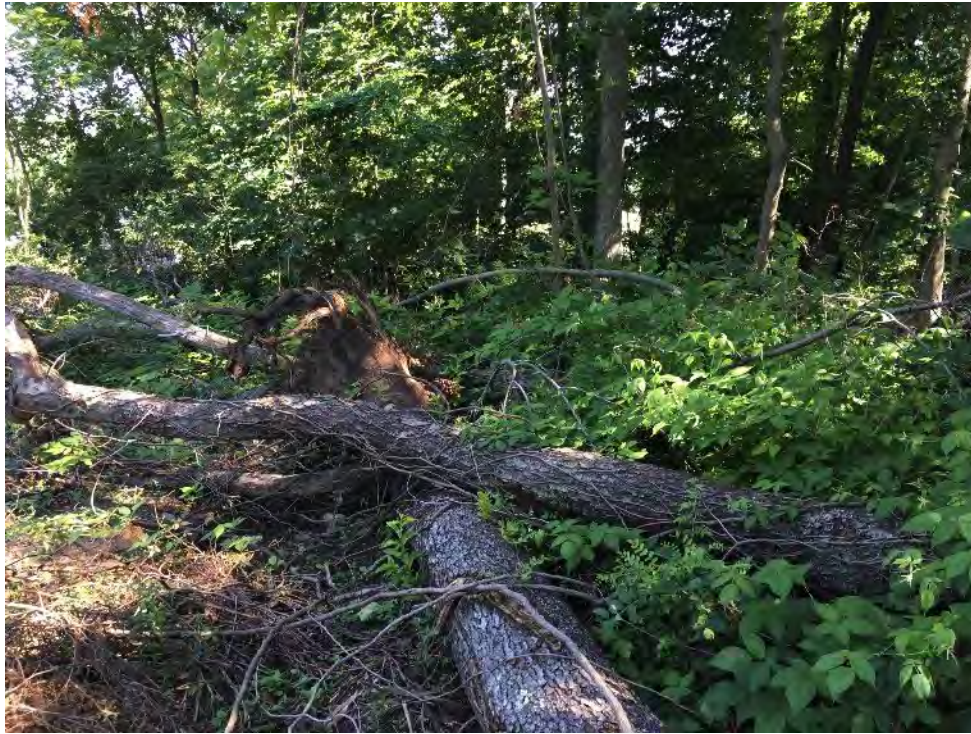
Date	Waypoint #	Photo #	JPEG File Number	Location Description	Cardinal Direction	Description of Photo Subject
7/9/18	7	9	shpimg_989.jpg	Insides W c; inside CR; CR all around	SE	Boundary line

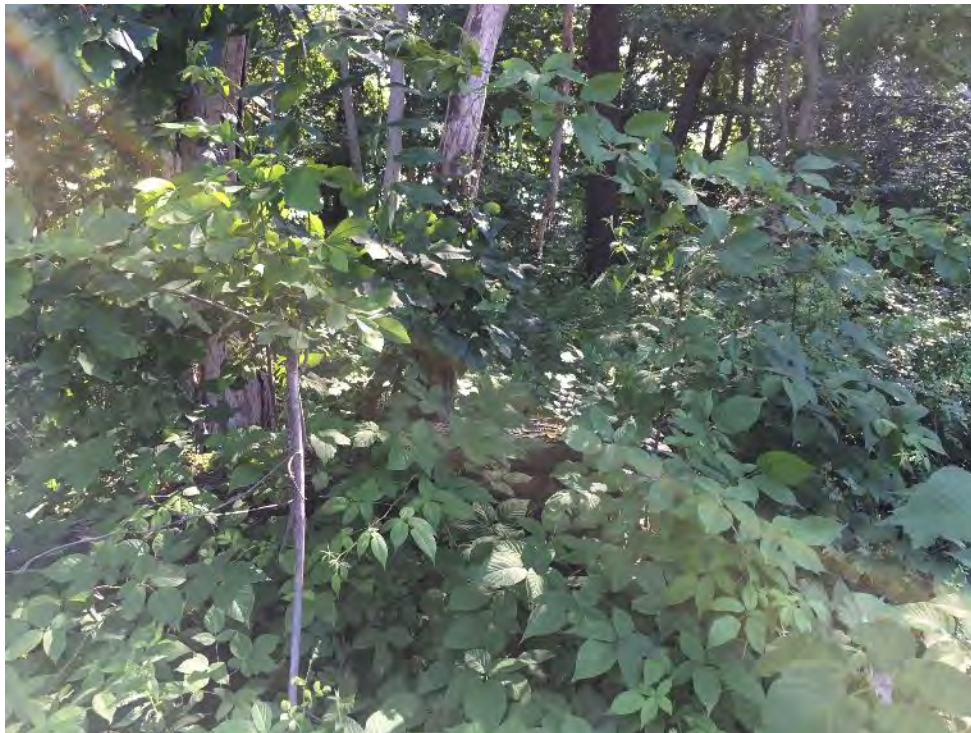
I walked the site's boundary and found it in its 'natural state' with a range of tree and shrub species along with the usual exotic invaders such as multiflora rose and oriental bittersweet [WP 7/photo(s) 10]. Overall, the forests were abundant with birds, squirrels and white-tailed deer. After speaking with several abutters, it became clear that this is a highly valued site which incidentally adds a great deal of value to their homes. Unfortunately some abutters dispose of their yard waste on the site and even remove trees for personal reasons [WP 22/photo(s) 40], [WP 32/photo(s) 58], and [WP 23/photo(s) 42]. Several abutters are unclear about the location of their property line and/or choose to ignore the nearby boundary markers [WP 27/

- (1) During my inspection of the site, I observed several species of invasive plants and nuisance species. These include most notably oriental bittersweet, multiflora rose, and poison ivy [WP 7/photo(s) 10], [WP 22/photo(s) 39], and [WP 37/photo(s) 65]. The Weymouth team discussed the management of invasive and nuisance species during our interview. At this point, they have chosen to manage only problem plants in areas where the public is most likely to have contact; this does not include the site's wooded areas. They have no intention of using herbicides and will keep unwanted species at bay with routine mowing.

Date	Waypoint #	Photo #	JPEG File Number	Location Description	Cardinal Direction	Description of Photo Subject
7/9/18	7	10	shpimg_990.jpg	Insides W c; inside CR; CR to right	SW	Thick overgrowth on boundary line
